## Documenting and Restoring Aspects of Damage of the Historic L'Atelier D'Alexandrie (Timfako Palace) in Alexandria, Egypt

Ola M. Mohammed Ahmed

Interior architecture department, Faculty of fine arts, Alexandria University, Alexandria, Egypt, FA.OLA.MOHAMED@alexu.edu.eg

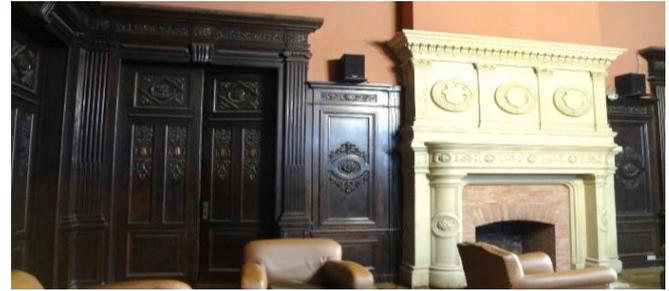
In addition, two doors open on the northern wall of the hall, with a fireplace built of artificial stone, signage bricks (refractory bricks), and a cast-iron firehouse in the middle. [31]

Figure 25. The built-in fireplace is made of artificial stone and signage bricks (refractory bricks). [15]

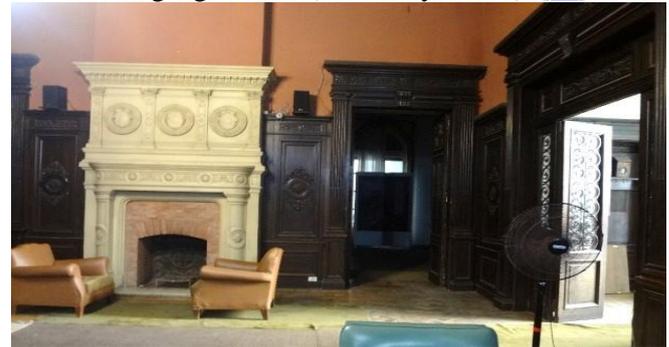
Figure 26. Fireplace built with a cast-iron firehouse in the middle. [15]

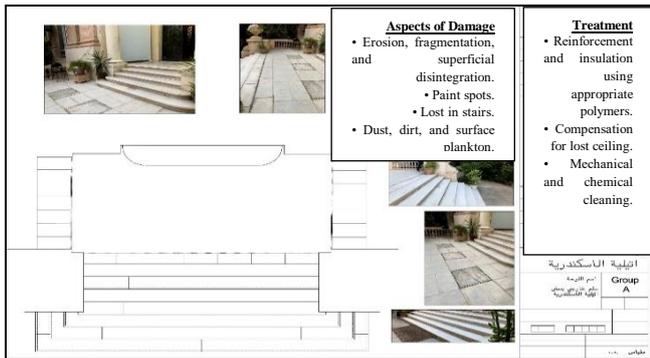
Figure 47. Architectural documentation of marble stairs in the exterior area. [15]

**Aspects of Damage**

- Erosion, fragmentation, and superficial disintegration.
- Paint spots.
- Lost in stairs.
- Dust, dirt, and surface plankton.

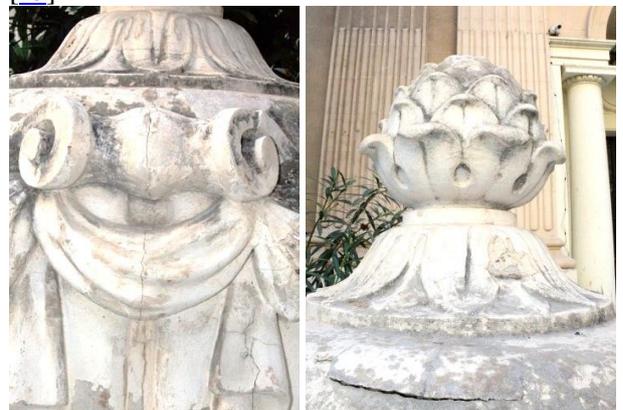
Figure 52. Details of damaged aspects in

sculptures. [15]

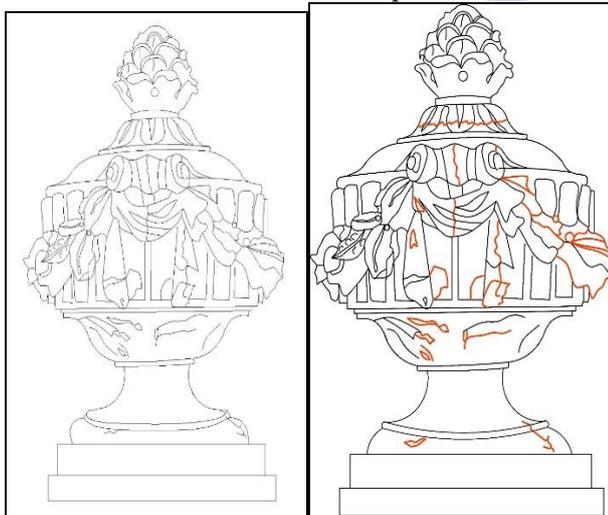
**Figure 54.** Architecture documentation of sculpture in the exterior area. [15]

**Aspects of Damage**

- Wrong paint.
- Missing places.
- Cracks.

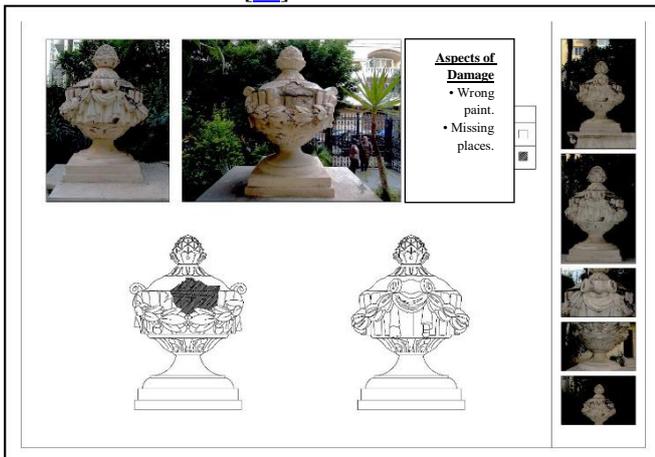
**Figure 55.** The documentation of damage aspects in the exterior area. [15]

**Aspects of Damage**

- Wrong paint.
- Missing places.

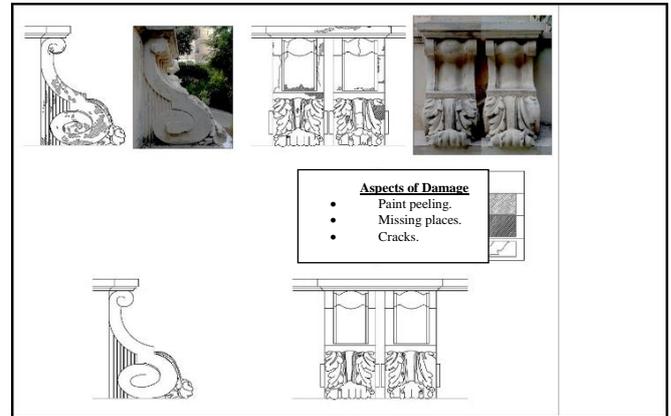
**Figure 56.** Damage aspects of ornamental details in sculptures. [15]

**Aspects of Damage**

- Paint peeling.
- Missing places.
- Cracks.

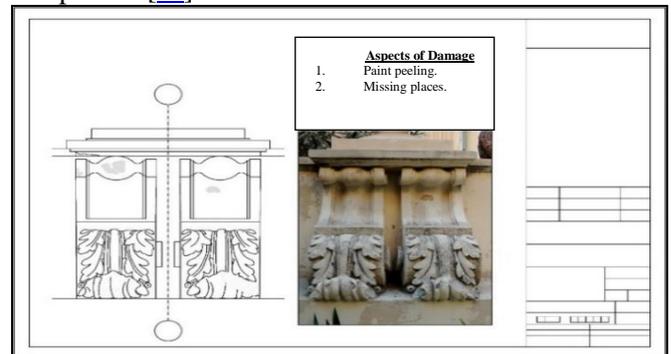
**Aspects of Damage**

- Paint peeling.
- Missing places.

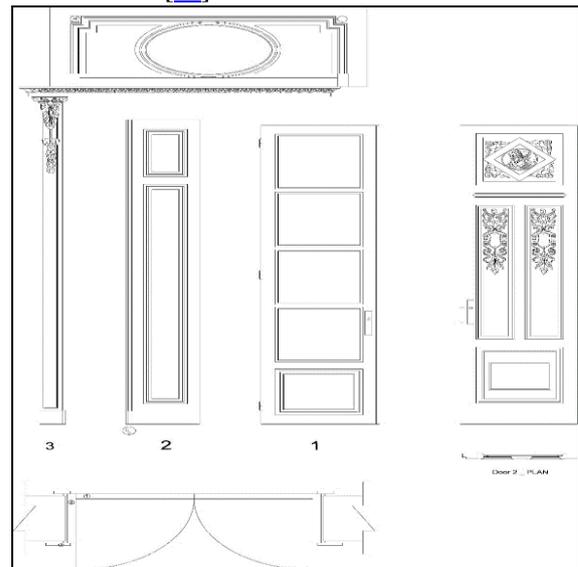
Figure 64. Architectural documentation of a wooden door. [15]

<p><b>Aspects of Damage and Deterioration</b></p> <ul style="list-style-type: none"> <li>•Erosion, fragmentation, and superficial disintegration.</li> <li>•Paint spots.</li> <li>•Novel items.</li> <li>•Randomly distributed electrical wires and connections.</li> <li>•Dust, dirt, and</li> </ul>	<p><b>Treatment</b></p> <ul style="list-style-type: none"> <li>•Reinforcement and insulation using appropriate polymers.</li> <li>•Removed and processed to match specifications.</li> <li>•Mechanical and chemical cleaning.</li> </ul>
	<p>وزارة الآثار مديرية أسيوط مركز توثيق الآثار اسم المجموعة Group A الاسم الفرعي للمجموعة الاسم الفرعي للمجموعة</p>

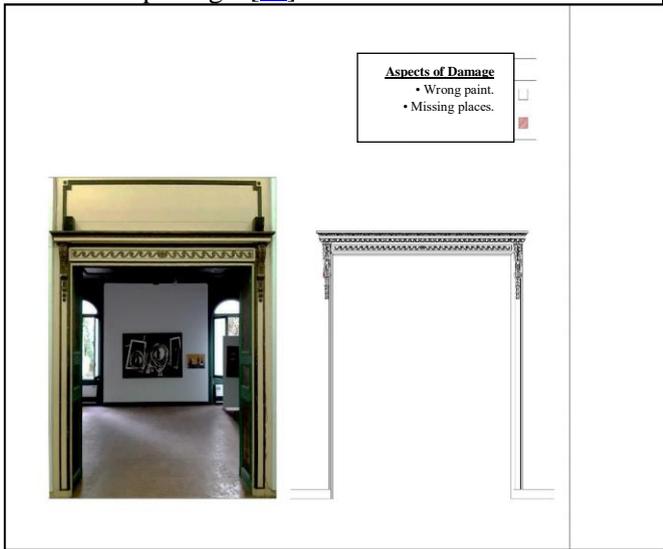
**Aspects of Damage**

- Wrong paint.
- Missing places.

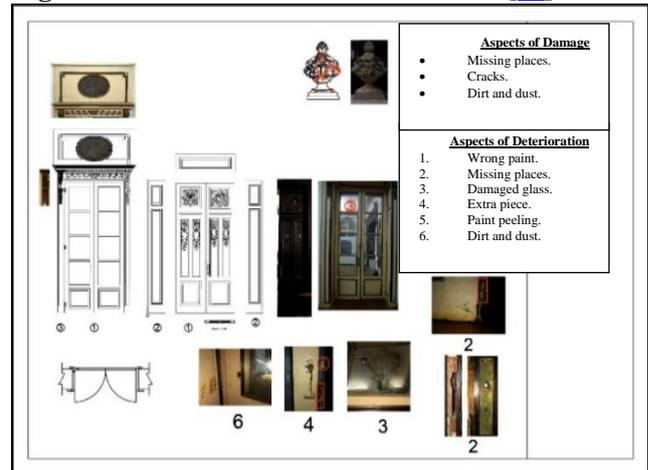
Figure 79. The documentation of damage aspects of a wooden door. [15]

**Aspects of Damage**

- Missing places.
- Cracks.
- Dirt and dust.

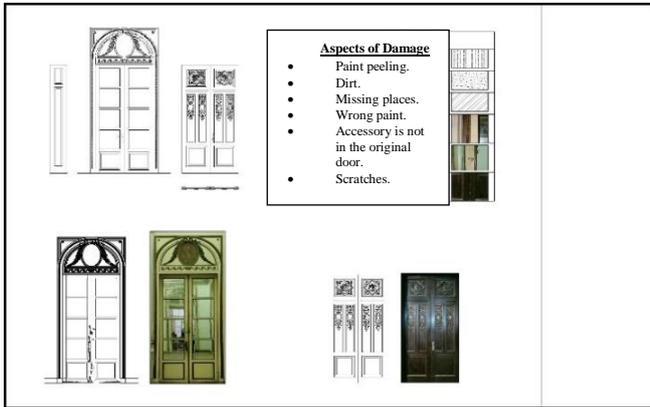
### Aspects of Damage

- Paint peeling.
- Dirt.
- Missing places.
- Wrong paint.
- The accessory is not in the original door.
- Scratches.

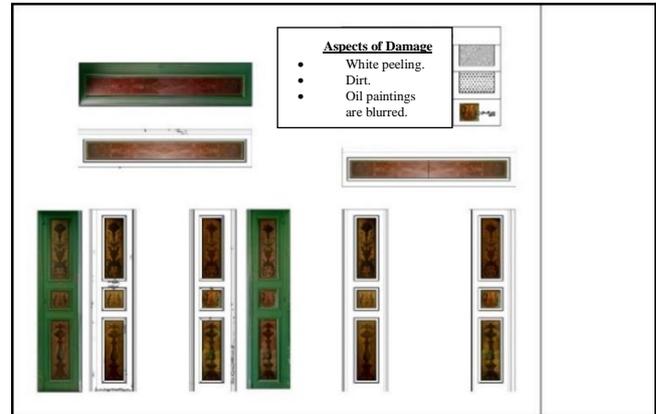
### Aspects of Damage

- Paint peeling.
- Dirt.
- Oil paintings are blurred.
